**Flood Control Project Maintenance
Levee Inspections**
LMA District Cover Sheet
Spring 2010 Levee Inspection Results

Reclamation District No. 1660 Tisdale

Levee Inspection Report By Mile - Spring 2010

Waterway						Bank	Unit Miles	Inspection Start/End	Inspector	
Unit No. 01 Sacramento River						Left	3.00	05/12/2010 05/12/2010	Bob Duffey

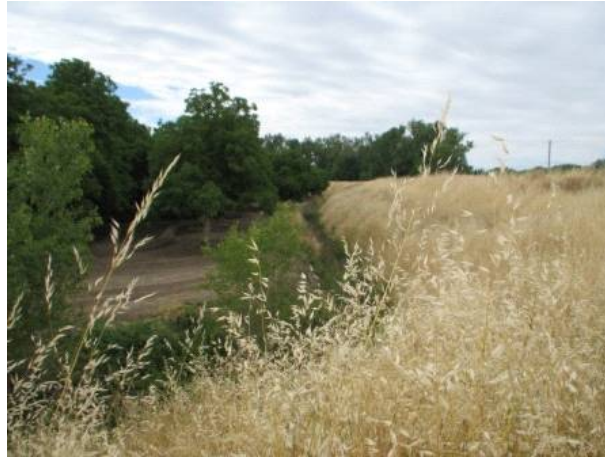
rduffey_s_20100622_060.jpg

Levee Mile Report Line	1
Start Levee Mile	2.04
End Levee Mile	2.38
Location	Land Side
Category	Earthen Levee
Item	Encroachments

View of the large ditch along the landside toe.

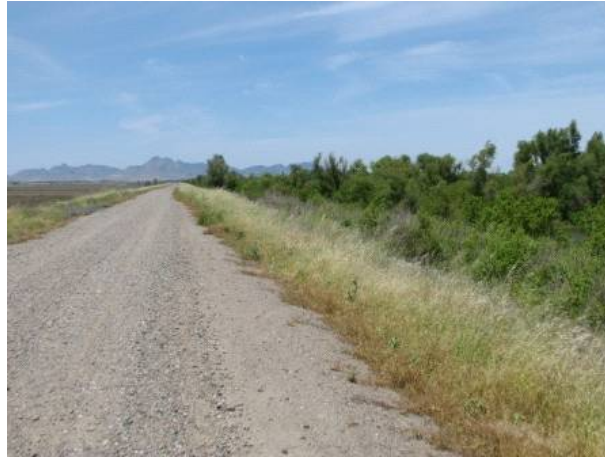
rduffey_s_20100622_061.jpg

Levee Mile Report Line	1
Start Levee Mile	0.06
End Levee Mile	0.44
Location	Water Side
Category	Earthen Levee
Item	Trim / Thin Trees

View of the trees along the waterside slope of the levee.
